THE FUTURE IS TRENCHLESS – REHABILITATION OF PRESSURE INFRASTRUCTURE IN NELSON, NZ

Katharina Helming

Business Development Manager, SAERTEX multiCom GmbH

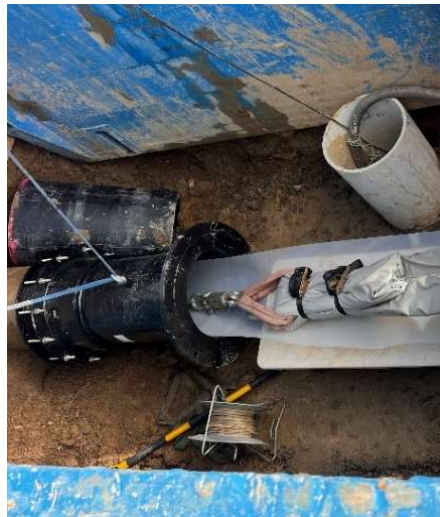
A new piece of pipe must be mounted on the host pipe to prepare the ends of the liner. This can be done by different methods such as welding on a new piece of pipe, connect it with a coupling or using a CIP JOINT from NovaSiria®. This is necessary to ensure a proper end connection of the liner with the existing network to ensure a leak tight system. For this project, a CIP JOINT from NovaSiria® was preferred for the end connection due to its ease of handling and maintenance of the same inner diameter as the host pipe. This is a combination of a coupling and a new piece of pipe either with or without flange, which will be slipped over the host pipe and secured with the integrated coupling. Picture 1 shows an example of a mounted CIP JOINT on one of the sections of the project.

Picture 1: CIP JOINT of NovaSiria® mounted on the host pipe

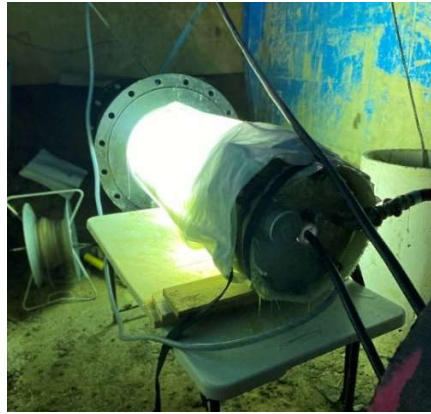
Before inserting the UV-light chain into the trench, the lamps are checked for functionality. The UV light chain is then inserted into the liner and pulled from the excavation pit to the starting point of the curing. Curing starts when the UV light bulbs are turned on and the light source is gently pulled backwards through the liner at a prescribed speed. The curing of one of the sections is shown in Picture 2.

Picture 2: Curing of the SAERTEX-LINER®

A visual inspection and monitoring of technical parameters is conducted via the UV Unit and is continuously documented during the curing. The protocol has a crucial role in ensuring that the installation is executed in strict accordance with the installation manual and parameters prescribed by SAERTEX multiCom®.

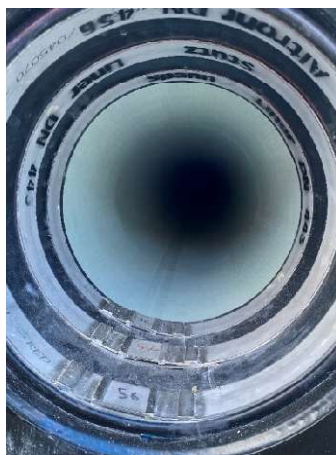
After the liner installation, end seals are installed to connect the liner to the network and prevent groundwater from penetrating the cut edged of the composite material. These seals consist of an EPDM rubber band with 3 to 4 steel bands depending on the pipe diameter. The cured liner is cut back about 10 cm to fit the rubber, which is secured with the steel bands. After 24 hours, the bands are retightened as the rubber settles. The installation is completed by installing seals on both ends, as shown in Picture 3.

Picture 3: Installed Liner and Liner End Seals

The final stage involved several critical tasks to ensure the pipe could be securely reconnected to the network. This included a CCTV inspection to visually assess the liner's condition and placement within the pipe and a pressure test to assess the integrity, stability and leak tightness of the installed liner. For this project, pressure testing was done for both sections each, providing an additional layer of documentation and quality assurance for the entire system. The two liners installed in Nelson have been pressure tested successfully at a set test pressure of 9 bar.
