WHEN THE MANNING RIVER ROSE – WINGHAM WATER DROPPED & THE MIDCOAST TEAM STEPPED UP

In May 2025, the MidCoast region of NSW experienced the most extreme flood on record with the Manning River peaking above the 0.2% AEP event. Amongst the widespread impact on infrastructure, MidCoast Council's Water and Sewer team demonstrated agility, expertise and resilience in maintaining essential services for around 43,000 connections

This paper presents a case study of the impacts experienced as well as the operational strategies and emergency actions undertaken during the flood, including key responses across sewerage systems, water treatment plants and the water supply to Wingham. It also outlines the system recovery process, infrastructure adaptation measures and key learnings for flood resilience planning in regional water utilities.

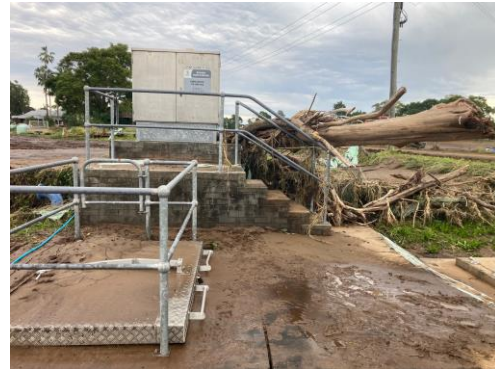
Figure 5 - Taree SPS#4 - Flood Rack & Mud

Despite widespread inundation, rapid system recovery enabled all SPSs to be restored within two days of the peak, except for seven (7) SPSs in Taree that remained inundated by floodwater. This recovery was aided by the spare switchboards held in our depot that could be swapped over quickly for ones that had been fully emerged in floodwater. Other boards were rewired with new components held as spares or cannibalised from other sites.

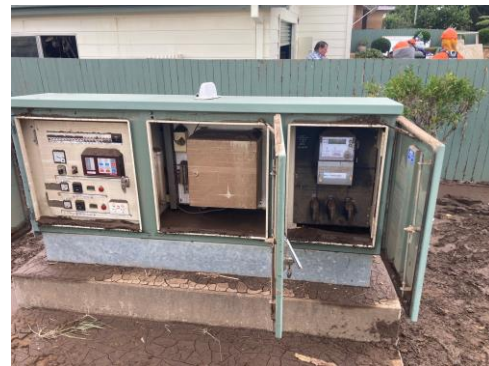
- Previous efforts to raise switchboards above flood heights were helpful. Even though some of these switchboards were still impacted, the level of damage meant that they could be partially rewired quickly rather than having to be fully rewired. Many of these sites ended up with water getting into the pump motors

Figure 6 - Inundated SPS Switchboard

after tracking down the cables from the switchboard. Had the cable connections been fully sealed, we would have had less damage to our pumps from the event.

switchboards, the magnitude of this event partially submerged some of them, resulting in water entering the pump cables, damaging their motors. We were able to use spare boards kept at the depot to simply switch out with the flooded ones, returning them to service quickly. We also rewired those with minor damage.

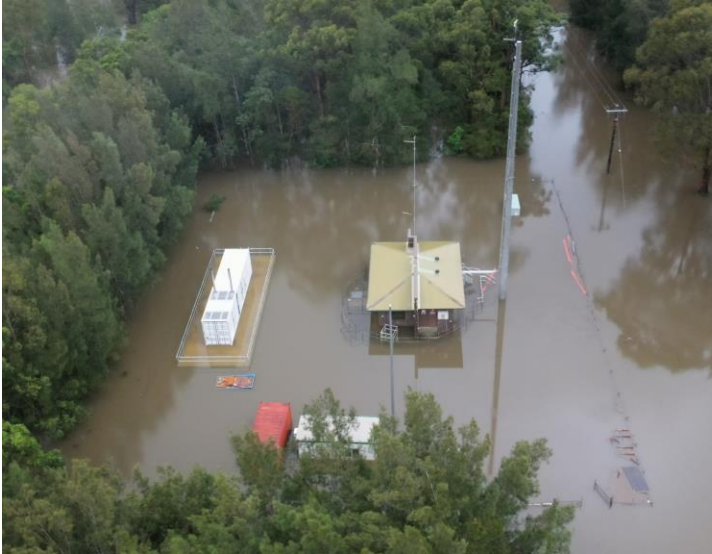
- Our largest SPS, Taree #06 dry pump well, was flooded and isolated. Our operators managed to remotely modify the PLC code to enable one of the submerged pumps to continue transferring sewage to Dawson Sewage Treatment Plant. Whilst the generator could still operate, the length of the flood peak meant that refueling it became a manual task.

Figure 7 - Taree SPS #6 - Flooded over the floor height but still operational & refueling the generator

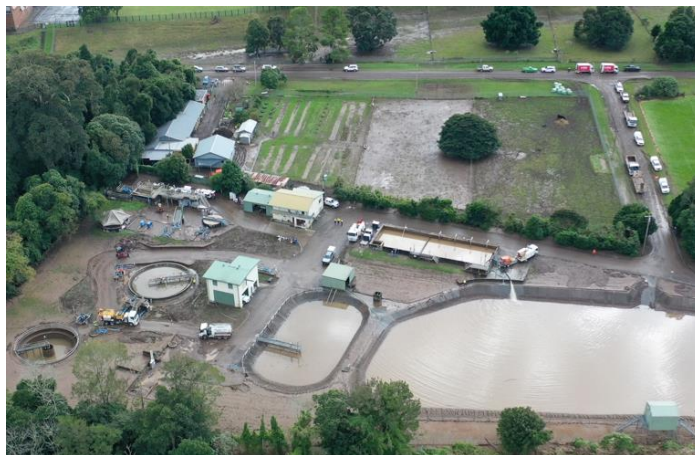
The Wingham Sewage Treatment Plant (STP) was completely submerged during the event, suffering substantial damage and accumulating mud and debris throughout the plant. Pre-planning for the event allowed for the relocation of some critical equipment prior to the flood.

Figure 8 - Wingham STP - Immediately Post Flood

Recovery included the removal of substantial mud and debris. Control cabinets were washed down, dried and rewired. Screen and temporary settlement were implemented within two days of the peak. Secondary treatment was resumed four days later.

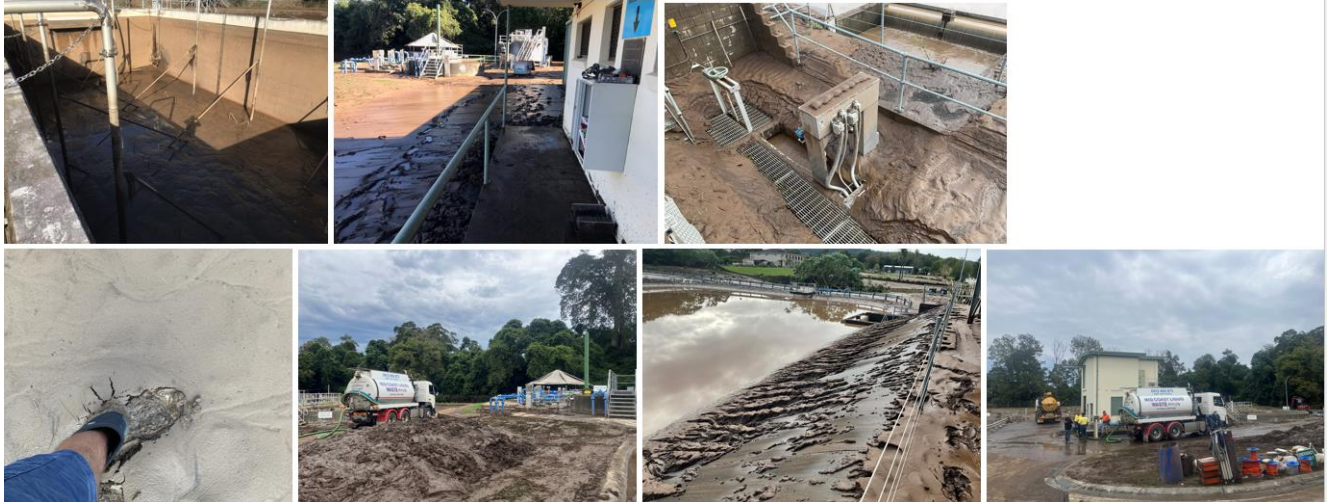
Figure 9 - Wingham STP - Post Flood Damage & Cleanup

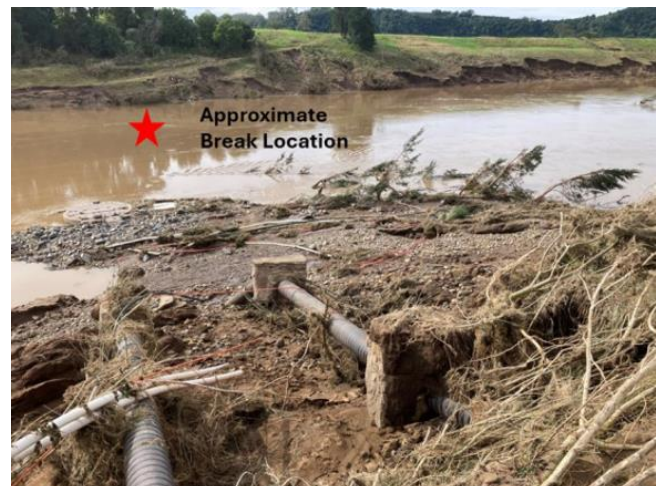
The flood had caused extensive erosion of the riverbank where the trunk main crossing had been constructed in 1968. Originally, the welded mild steel main was trenched through the riverbed, anchored with concrete trench stops and protected with rock-filled wire bags of a type similar to gabion baskets. Much of the protection has since disappeared.

Figure 13 - Approximate Location Of Pipeline Damage

damage to the pipeline resulted in the broken end being bent approximately 90 degrees towards downstream, rendering it unrepairable.

- *Fault investigation and planning for pipeline replacement* – Council resolved to accelerate a project to underbore the river estimated at \$5M with plans for this work to be complete within 5 months. Work is advancing quickly, including the construction of access roads ahead of the drilling equipment mobilising to the site.
