# Investigating the Impact of Recycled Water Use on Soil, Groundwater and Vegetation at Isaac Region, Qld

*Tahir Khan: Technical Officer Referrable Dams and Effluent Storages, Isaac Regional Council*

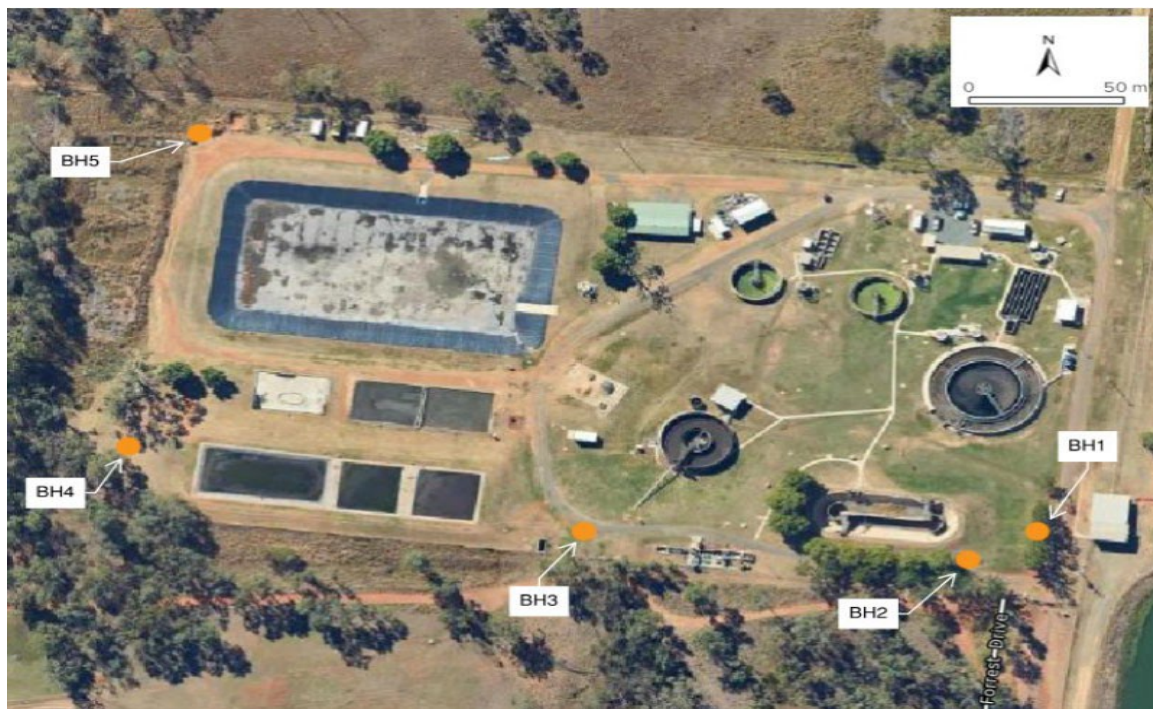
**Fig 1.1 Moranbah – Soil Sampling Points (Bio-Track) (Bligh Tanner REMP, 2022)**

EA conditions allow irrigation of 97 KL/day. Six soil sample locations were visually monitored monthly.

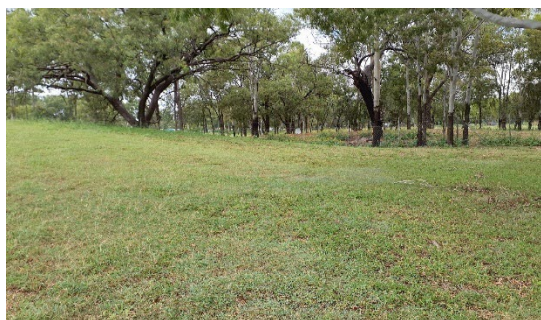
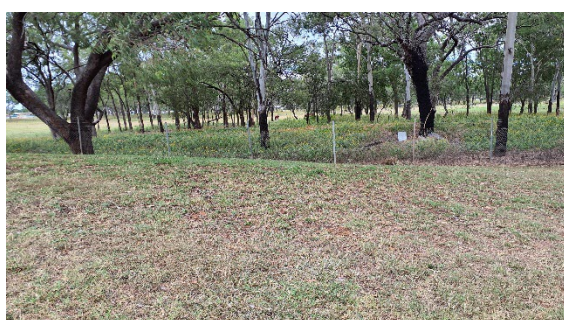
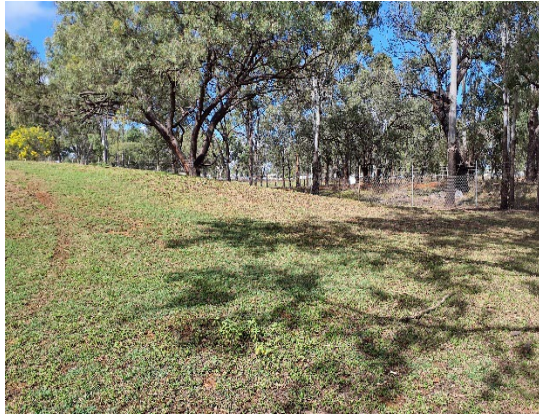
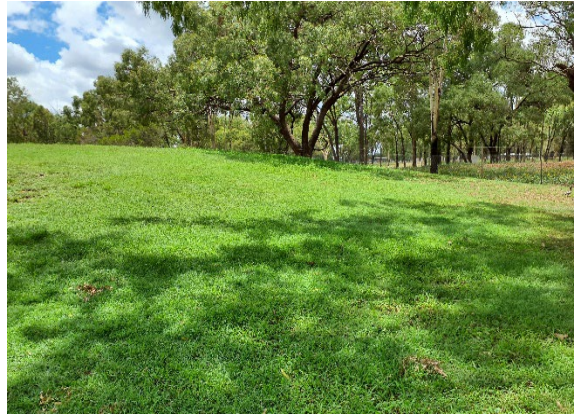
**Fig 1.3 Moranbah Site 2, On going Visual inspection monitoring the impact of Recycle water use on vegetation and soil over time.**

Effluent parameters met EA limits. Vegetation monitoring showed no negative effects; grasses thrived under irrigation and showed wilting symptoms when irrigation ceased. No surface salt accumulation was observed. Soil properties have remained stable for several years. groundwater data is still awaited. However, based on available data it is safe to claim that recycled water use at Moranbah WWTP is environmentally sustainable.
