# **Improving Hydraulic Performance of a 15km Recycled Water Rising Main using Ice Pigging Technology**

Authors: Ed Petts (SUEZ Water), John Carr (SA Water)

## **Abstract**

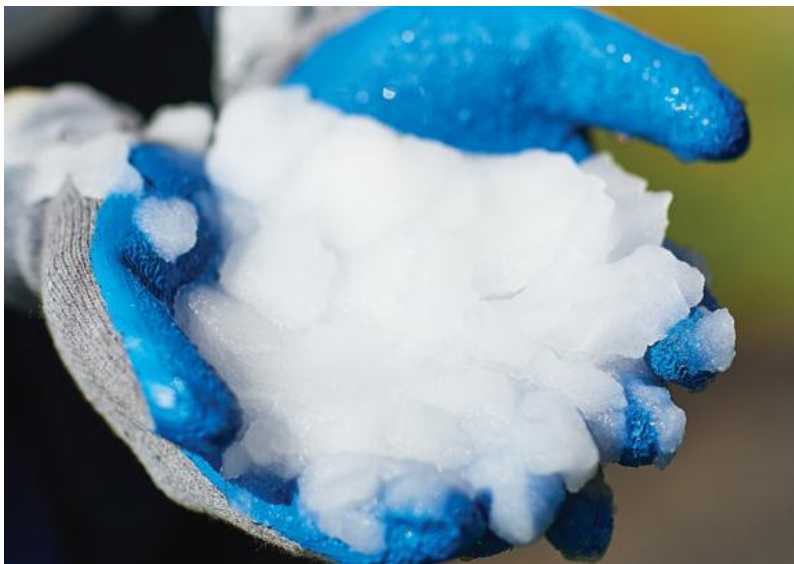
Ice Pigging technology is an innovative, non-invasive, and water-efficient method of cleaning pressurized pipelines using an ice slurry, a semi-solid, two-phase material. The ice behaves like a liquid whilst being pumped into the pipe and flowing through the pipe (navigating bends and changes in diameter), however with the abrasiveness of a solid, collecting loose materials and biofilms from within the pipe.

**FIGURE 1: THE ICE SLURRY**

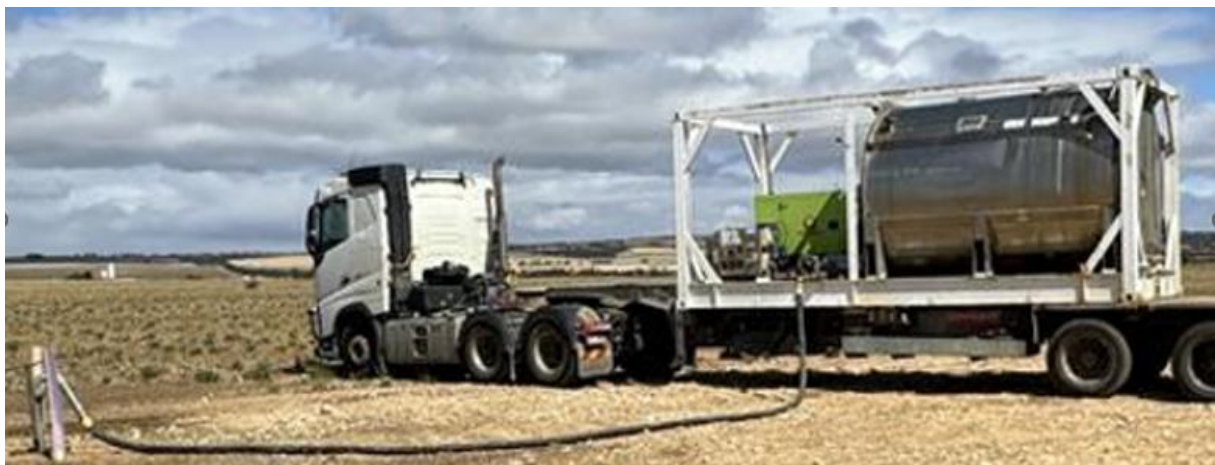
Existing Air Valves and Scour Valves were used for ice insertion and discharge with no excavations required.

FIGURE 3: INSERTION OF ICE INTO THE MAIN

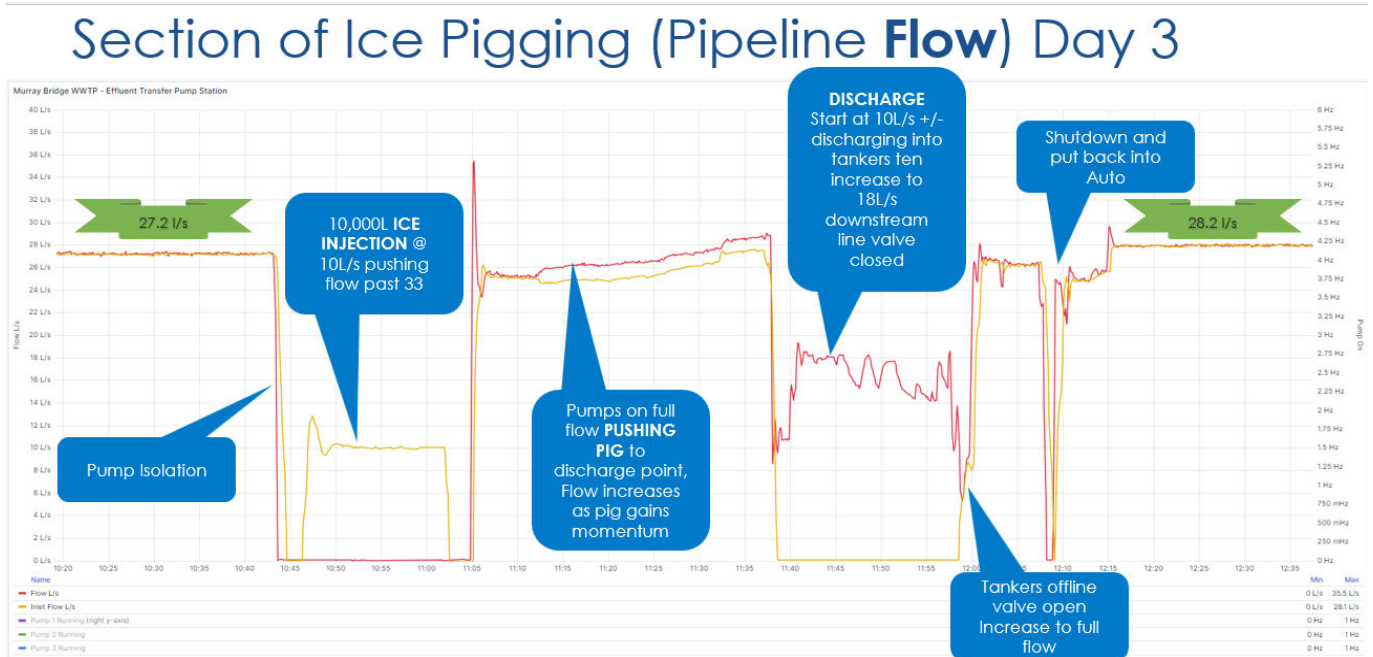
The entire process is described below and the Figure 4 shows a representation on Day 3. The red line showing the flowrate at the WWTP and the yellow line showing the flowrate into the lagoons.

1. Recycled water pumps isolated at the WWTP
2. 10,000L of ice then injected into the insertion fitting (adapted air valve)
3. Recycled water pumps turned back on, with pipeline in normal operation discharging into the lagoons

4. A small amount of recycled water was allowed out from discharge fitting (< 0.5L/s) and collected in a waste tanker. To monitor and indicate when the ice was near, by a reduction in temperature and increase in turbidity.

5. When ice was imminent the recycled water pumps were reduced to 10L/s, the discharge fitting opened to collect the ice into the waste tanker, and a downstream valve on the pipeline closed to ensure all of the ice was collected into the tanker. The pumps were then increased to 18L/s. Once all of the ice was collected the downstream valve was opened again and the pipeline returned to normal operation.

6. The entire operation took less than 2 hours, with less than 30 minutes where the recycled water pumps were not transferring recycled water through the rising main

FIGURE 4: SCADA DEMONSTRATING THE ICE PIGGING DAILY OPERATION

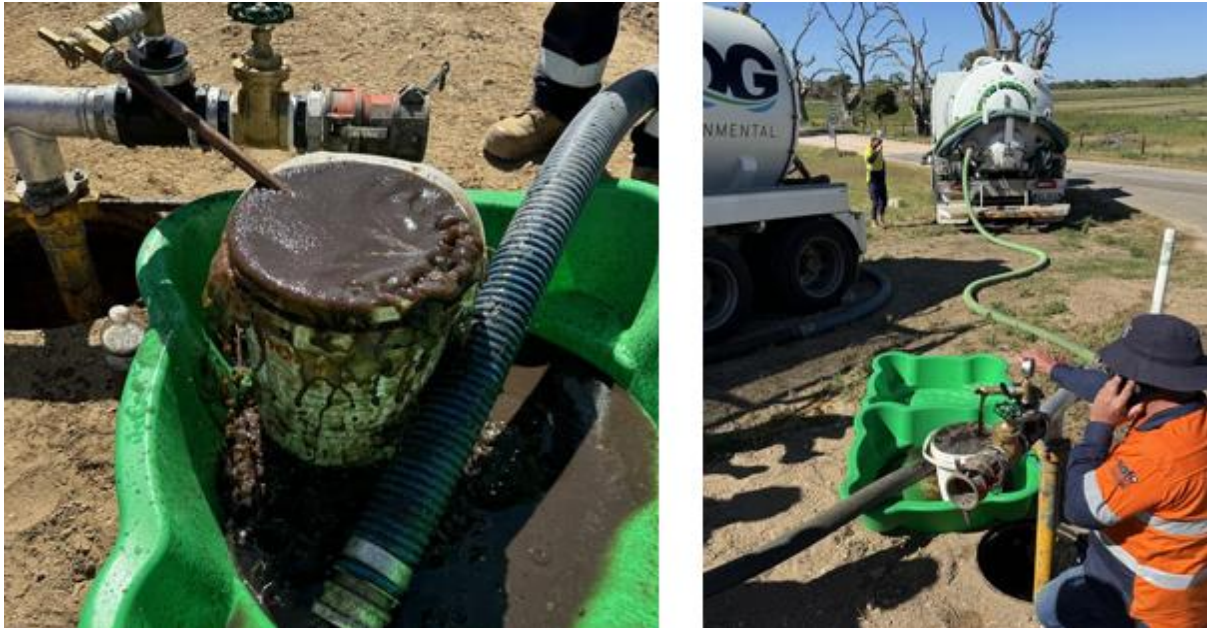
**FIGURE 5: DISCHARGE AND COLLECTION OF THE DIRTY ICE**

All of the ice was collected each day into a waste tanker for safe disposal, preventing any sludge or salt from entering the lagoons.

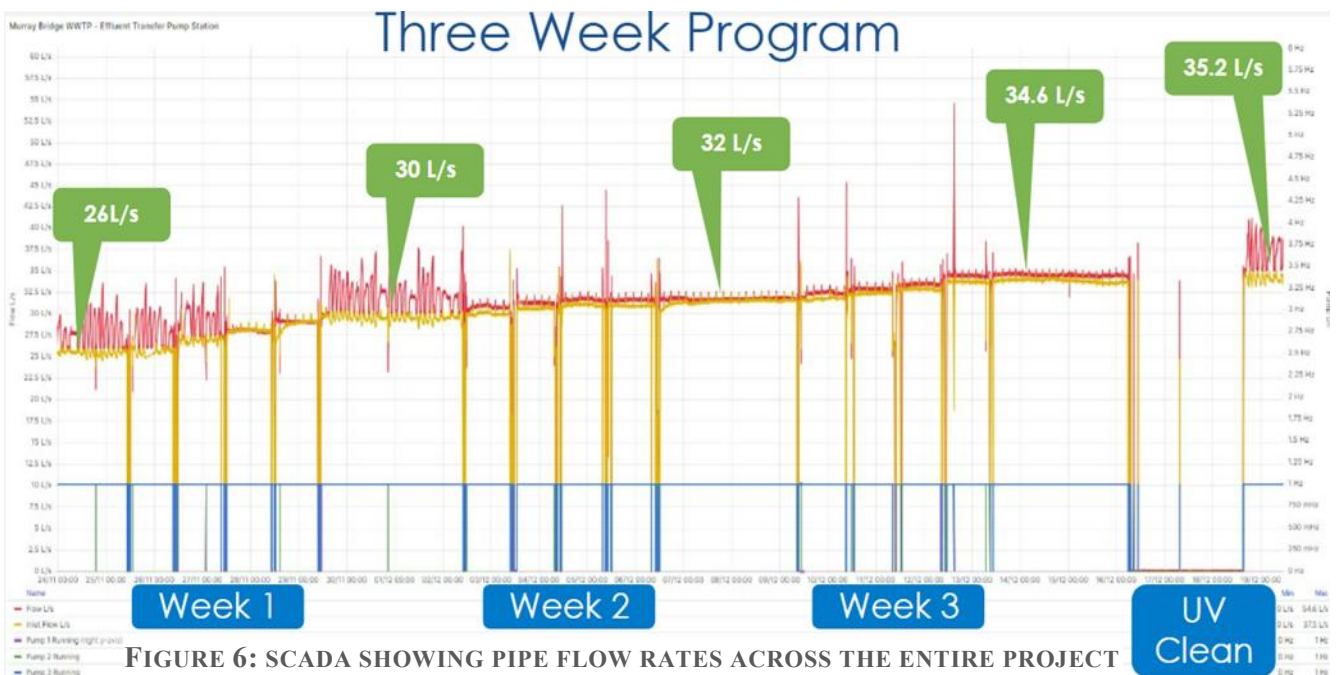
An increase in flowrate was observed after each Ice Pigging operation, as clearly demonstrated by the SCADA in Figure 6. Each dip indicates an Ice Pigging operation as the pumps were temporarily stopped for ice insertion. Hydraulic head loss was also reduced through the pipe. With the recycled water pumps (at the WWTP) running at 35kPa lower pressure (reduced from 775kPa to 740kPa), whilst the flow rate increased from 26.0L/s to 34.6L/s (33% increase). After a UV clean, **the flow rate was back up to 35L/s, and returned the rising main to its design capacity.**

**FIGURE 6: SCADA SHOWING PIPE FLOW RATES ACROSS THE ENTIRE PROJECT**

Post-cleaning SCADA data confirmed progressive and sustained improvements in hydraulic performance each day. Overall flow increased from 26.0 L/s to 34.6 L/s (33% increase), while pump discharge pressure reduced by approximately 35 kPa (from 775 kPa to 740 kPa), indicating a significant reduction in head loss. After a subsequent UV clean at the WWTP, the rising main was restored to its full design capacity of 35 L/s.

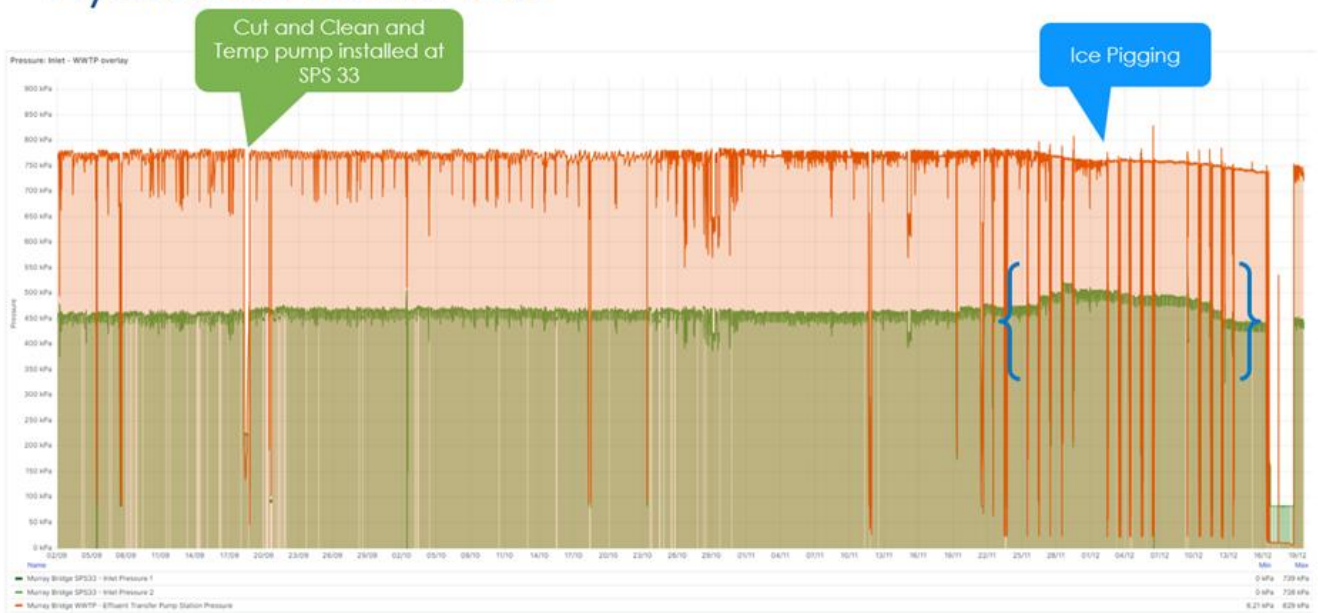
Hydraulic head loss is shown in the SCADA in Figure 7. The red line shows the pressure at the pumps at the WWTP, the green line shows the pressure at Sewer Pump Station (SPS) 33 (Note: no pumps are currently operating at this SPS) which is a third of the way along the pipe. The first 4 days of cleaning between the WWTP and SPS 33, show a reduction in pressure at the pumps, and increase at SPS 33, this indicates this section of the pipe was most constricted and demonstrates a significant reduction the headloss. This is also equates to the biggest increase in flow observed after cleaning this section.

After day 4, sections downstream of SPS 33 were cleaned, from this point we observe a reduction in pressure at both the pumps at the WWTP and SPS 33, which demonstrates a reduction headloss in these sections downstream of SPS 33 (to the outlet of the pipe).

FIGURE 7: SCADA SHOWING PIPE PRESSURES
