SLUDGY SOLUTIONS: DEALING WITH EXCESSIVE SLUDGE AT BAROSSA WTP

Liam Tohill, *Water Production Engineer, SA Water*

Andrew Sawilski, *Wastewater & Reuse Treatment Manager South, SUEZ*

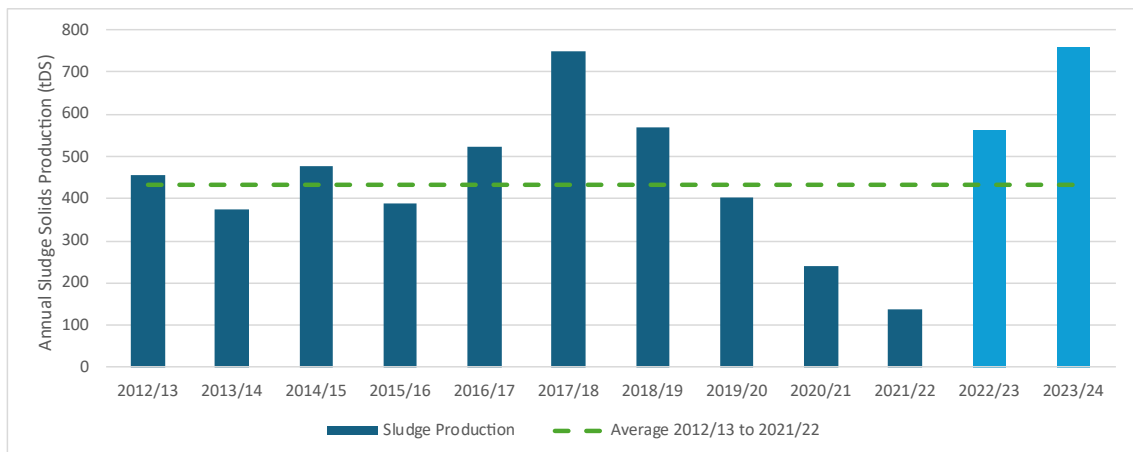
With higher water production and more sludge being generated by the treatment process, this resulted in the sludge production being significantly above average for 2 years in a row (Figure 1).

Figure 1: Modelled Annual Sludge Solids Production at Barossa WTP

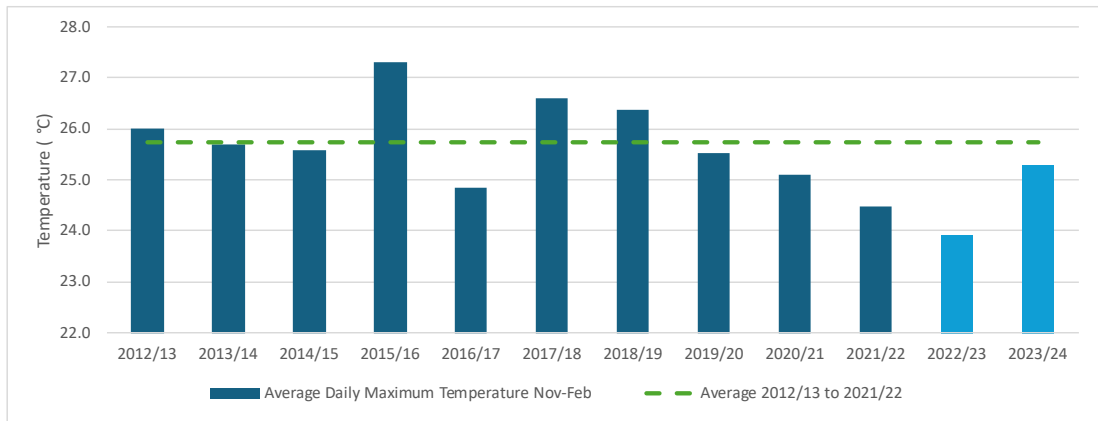
Secondly, the weather conditions during the drying season (November-February) were cooler than normal during these two years. The average daily maximum temperature during these months was lower than the average over the previous decade (Figure 2).

Figure 2: Average daily maximum temperature data nearby Barossa WTP during drying period (Nov-Feb)

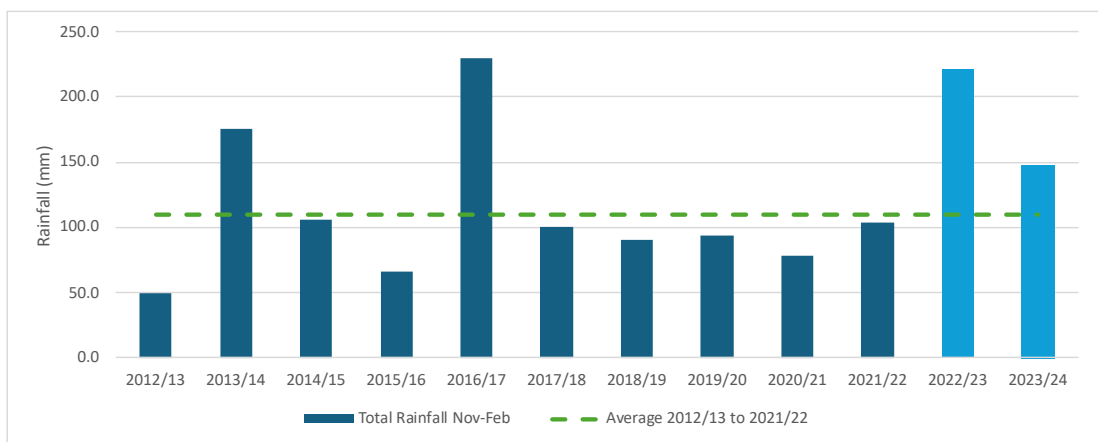
The final factor was that the drying season was also wetter than typical during these two years. The total rainfall between November and February was higher than the average over the previous decade (Figure 3).

Figure 3: Total rainfall data nearby Barossa WTP during drying period (Nov-Feb)

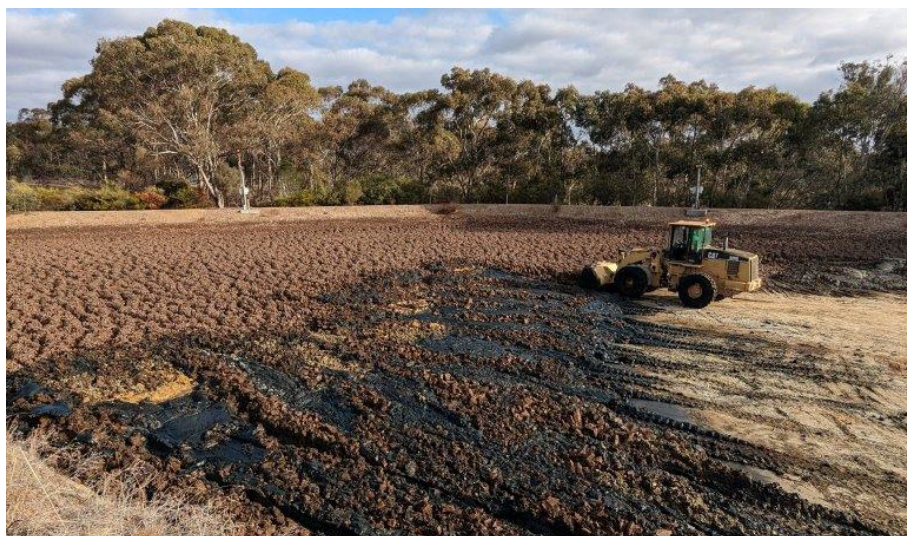
The combination of these three factors meant that it was significantly more challenging than normal to effectively dry the sludge. This culminated in the sludge in Lagoon 1 still being too wet to be able to remove effectively at the end of the drying season in 2024 (Figure 4).

Figure 4: Attempted desludging of Lagoon 1 with wet sludge at Barossa WTP

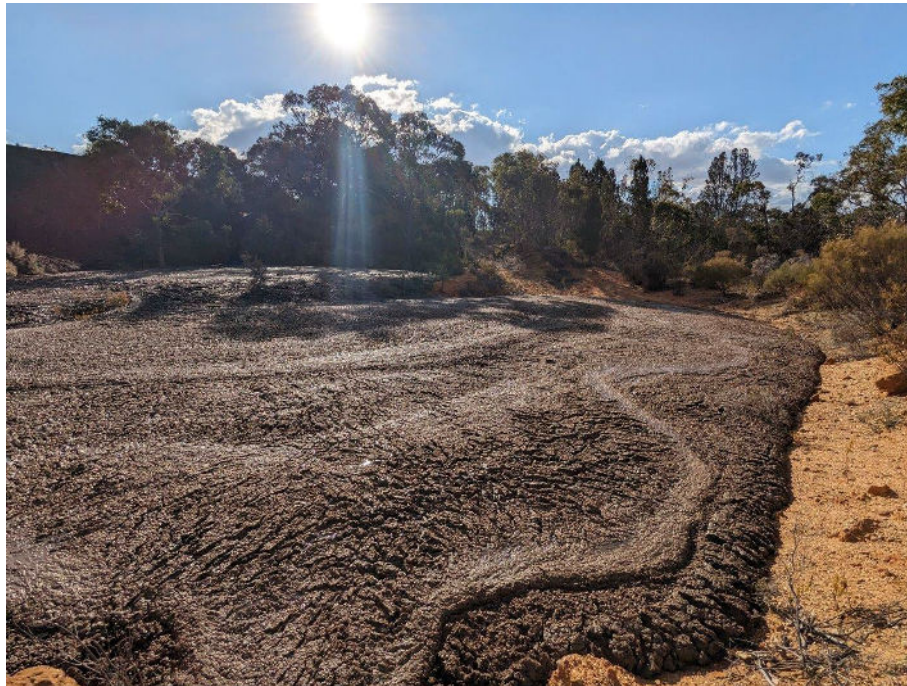
This wet sludge was unable to be safely disposed at the abandoned quarry (Figure 5). When the sludge was attempted to be disposed, it began to flow as a liquid slurry. If this was left un-checked, it may have resulted in a loss of sludge containment. Because of this, all further sludge movement was stopped, ensuring that no environmental incident would occur.

Figure 5: Inability of sludge to be disposed to abandoned quarry at Barossa WTP

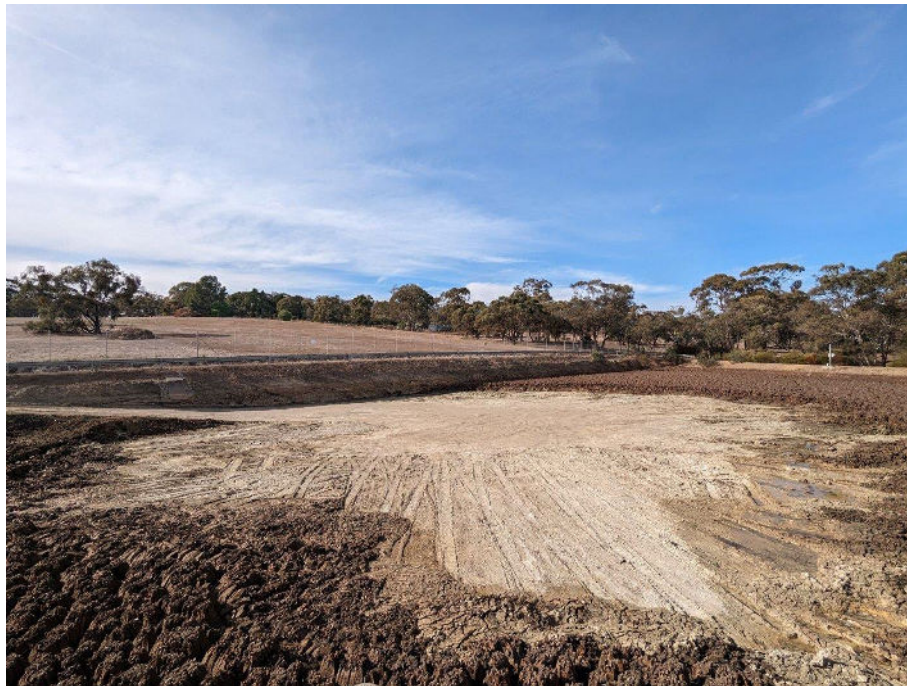
Sludge Lagoon 1, which had been attempted to be desludged at the end of the 2024 drying season, was only able to be partially emptied. Approximately one third of the total area of the lagoon was able to be cleared before the job had to be stopped due to the excessively wet nature of the sludge (Figure 6). The remaining sludge would require more time to dry sufficiently for removal.

Figure 6: Partially cleared Lagoon 1

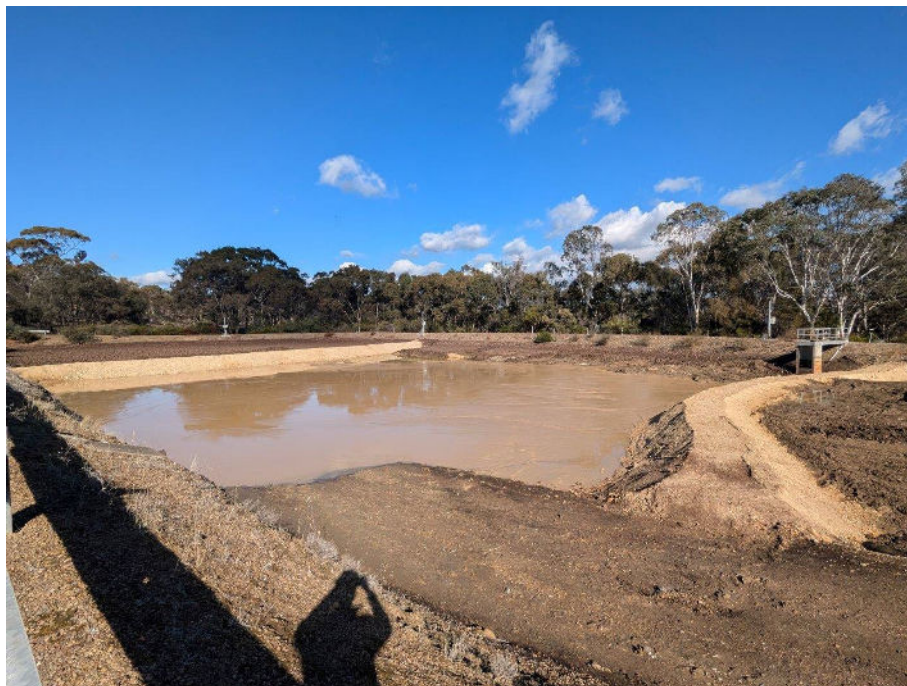
In order to allow the cleared area of the lagoon to be used for sludge drying without impacting on the partially dried sludge already in the lagoon, two earthen embankments were installed into the lagoon (Figure 7). Clean fill with a high clay content was sourced from a local quarry for this purpose.

Figure 7: Earthen embankments installed to Lagoon 1

These embankments ensured that Lagoon 1 would be partially available for the upcoming months of sludge production. In a typical year, this lagoon would be expected to be utilised for 6 months of sludge production. However, because only one third of the sludge lagoon capacity would be available, further actions were required to be taken to maximise the usage of the limited sludge handling capacity that was remaining.

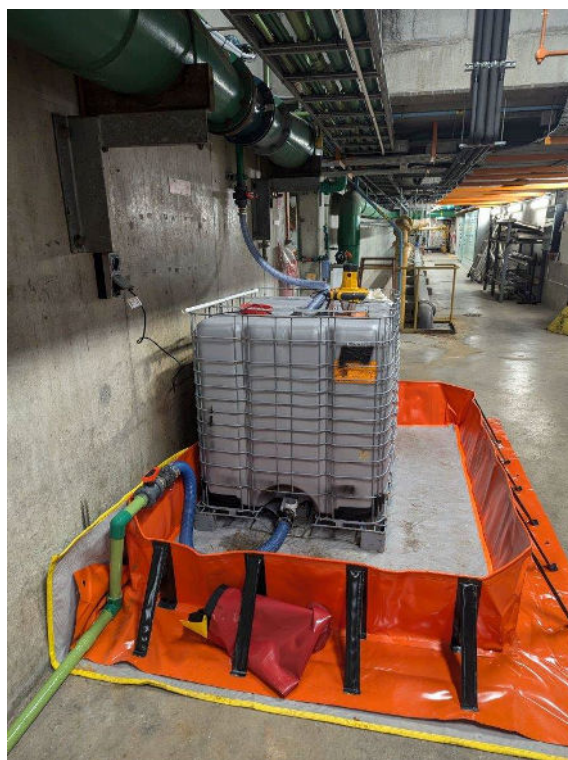
Lab testing showed that Magnafloc DW20 (non-ionic) was an effective sludge thickening aid. A temporary poly batching system was fabricated by the Maintenance team using a disused 1000 L container and an electric mixer (Figure 8). This was then plumbed into an existing dosing pump.

Figure 8: Temporary poly batching system

The critical part of the sludge thickening process that needed to be restored to service was the polyacrylamide dosing system. Barossa WTP already had an existing polyacrylamide batching and dosing system, with Magnafloc DW22S (cationic) being used as a flocculation aid. However, lab testing showed that this particular grade of polyacrylamide was ineffective as a sludge thickening aid. A full-scale trial also validated this finding. It was therefore determined that an alternative grade of polyacrylamide would be required as a sludge thickening aid.

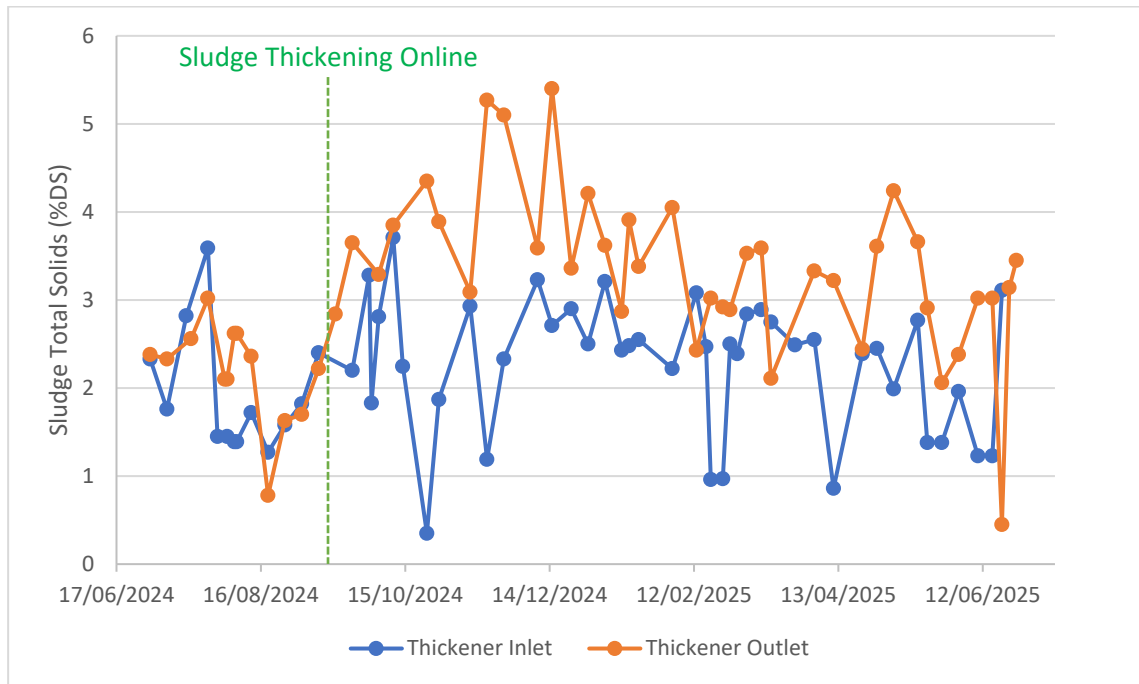
Once the sludge thickening process has been restored to service, a significant improvement in sludge thickness was observed (Figure 9). This resulted in a significant reduction in volume being pumped to the sludge drying beds and lagoons and ensured that the limited remaining capacity in the sludge drying beds and lagoons was able to be utilised optimally.

Figure 9: Sludge thickness improvement after sludge thickening process recommissioned

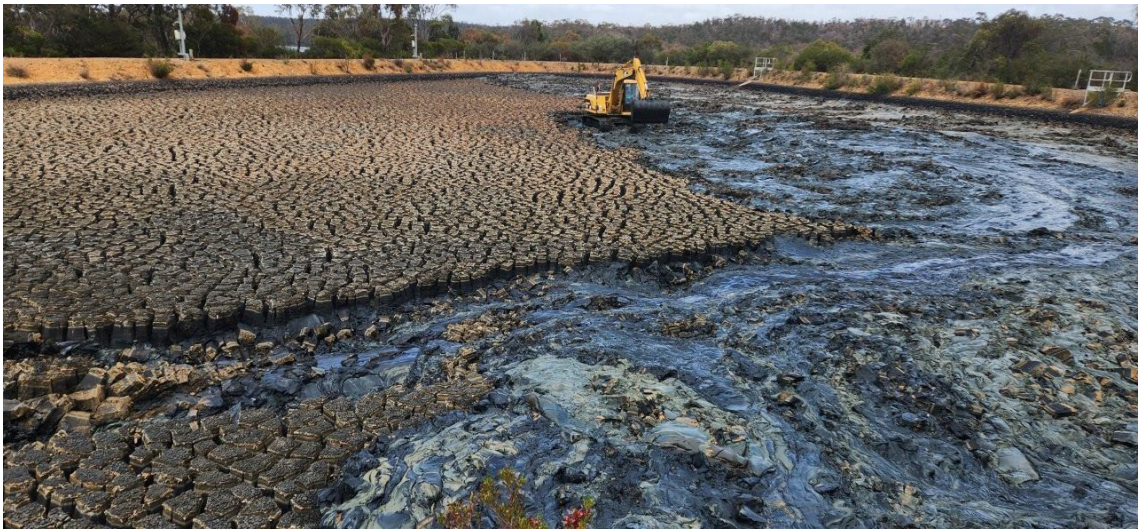
Because the sludge lagoons were not originally designed with underdrains, they take significantly longer to dry out. Without any free drainage, deeper sludge has a tendency to remain wet, even when the upper layer of sludge is relatively dry. In order to encourage the deeper sludge to dry out, a mid-season turnover of the sludge in the lagoon was implemented (Figure 10). Once the top layer of sludge has dried out, and the total depth of sludge reduced low enough to allow an excavator to enter the lagoon, the team engaged an earthmoving contractor to turnover the sludge in the lagoon. This ensured that the wet sludge was brought up to the surface and accelerated the drying process. This reduces the risk of the sludge still being too wet to remove at the end of the drying season.

Figure 10: Lagoon 2 being turned over

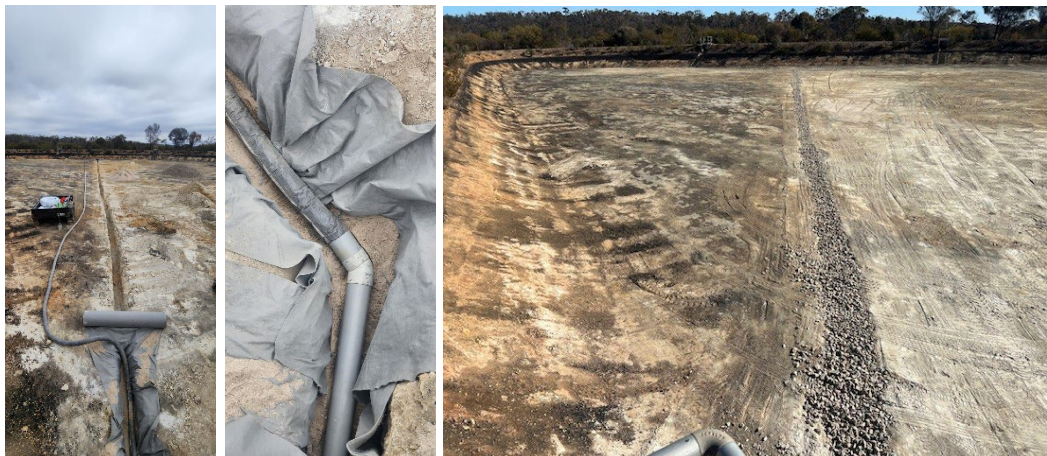
Given the lack of underdrains in the sludge lagoons, the local Operations team determined that it would be possible to install a basic underdrain into the lagoons. These lagoons do not have any liner, with the local geology being relatively impermeable. This allowed for an underdrain pipe to be installed directly into the base of the lagoon, with a cover of sand and gravel (Figure 11). Going forward, as each lagoon is dried and emptied, an underdrain pipe is being installed through the centre of the lagoon. This will assist further at improving the capacity of these lagoons to dewater the sludge.

Figure 11: Underdrain pipe installed to base of Lagoon 2

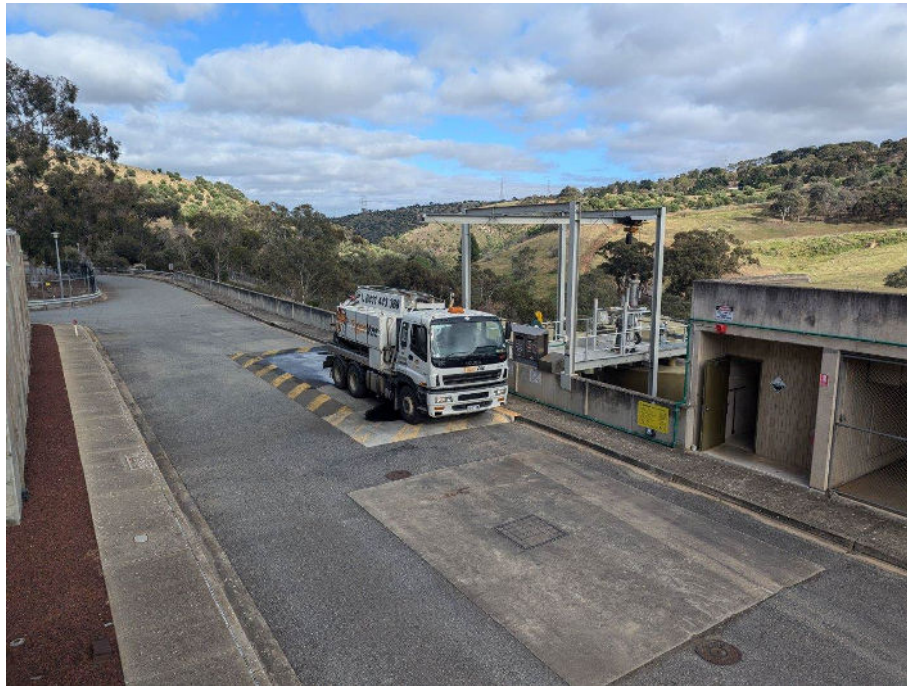
The Maintenance Team worked to install a 100mm camlock connection to the thickened sludge pipe at Barossa WTP for the vacuum trucks to load. A 100mm camlock connection was also installed at Little Para WTP to the sludge tank to for the vacuum trucks to unload (Figure 12). The unloading connection point at Little Para WTP was located within the chemical delivery bund, to ensure that any sludge spills would be captured and avoid a potential environmental incident.

Figure 12: Vacuum truck unloading sludge at Little Para WTP

From November 2024 to January 2025, the level of sludge in Lagoon 1 was assessed each week, and a schedule was put in-place for vacuum trucks. This ensured that the capacity of the onsite sludge treatment was maximised, and only the excess sludge was carted to Little Para WTP. This helped to ensure that the cost of this process was managed to be as low as possible. Over the course of this period, a total of 2.5 ML of sludge was carted from Barossa WTP to Little Para WTP, ensuring that the sludge level in Lagoon 1 remained below the maximum capacity.
