# DAYS NOT MONTHS: CITY OF GOLD COAST'S EMERGENCY PRESSURE PIPE REHABILITATION PROGRAM

## ABSTRACT

## 3. HOPE ISLAND ROAD: THE CENTREPIECE CASE

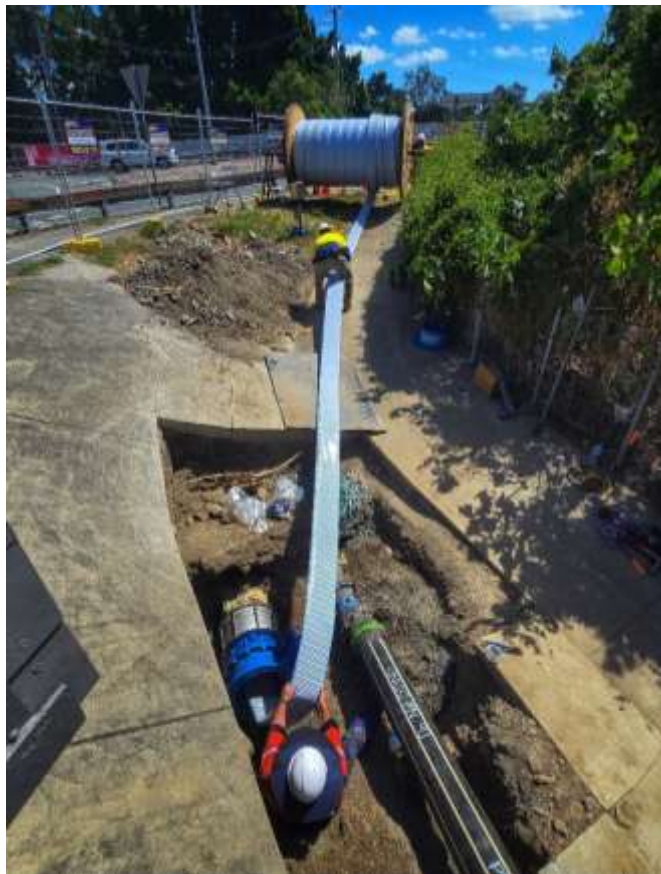
*Figure 2: Primus Liner being pulled from the transport reel into the access pit during the Hope Island Road installation. The compact reel and minimal site footprint are characteristic of the system.*

Installation requires two access pits — one at each end of the rehabilitation section. The pre-folded liner is delivered on a compact transport reel that can be positioned at the entry pit with standard site equipment. A winching cable is threaded through the host pipe and attached to the liner's end. The liner is then pulled through in a single continuous operation — including any bends — and expands to its circular cross-section applying air pressure. Specially developed end connectors are installed at both pits to integrate the rehabilitated section with the existing network. Pressure testing follows, and the section is returned to service.

Two access pits were excavated, one at each end of the 130 m section. The Primus Liner DN400 PN18 was positioned on its transport reel at the entry pit. A winching cable was threaded through the host pipe, connected to the pre-folded liner, and the liner was pulled through the full 130 m length — navigating several bends including a 90-degree bend — in under 30 minutes.

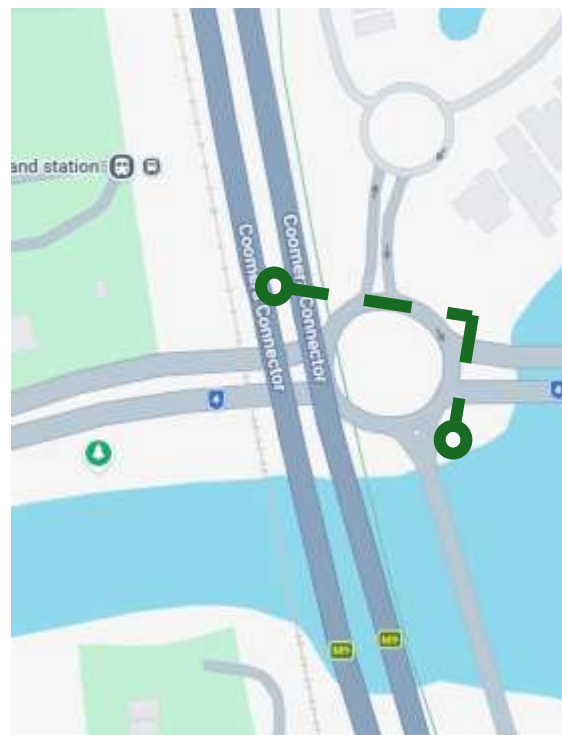
Figure 4: Detailed satellite view of the Hope Island Road project site, showing the new Coomera Connector, the major roundabout beneath which the DN400 recycled water main runs, and the approximate pipeline rehabilitation route.

The failed asset was a DN400 Class A recycled water main. The pipeline comprised a combination of ductile iron cement-lined (DICL) and PVC pipe, reflecting the mix of materials typical of infrastructure built and extended across different eras. The rehabilitation section was 130 m in length and included unknown bends of up to 90 degrees — located within the roundabout footprint, beneath active road pavement. Maximum operating pressure (MOP) was 7.5 bar / 750 kpa.

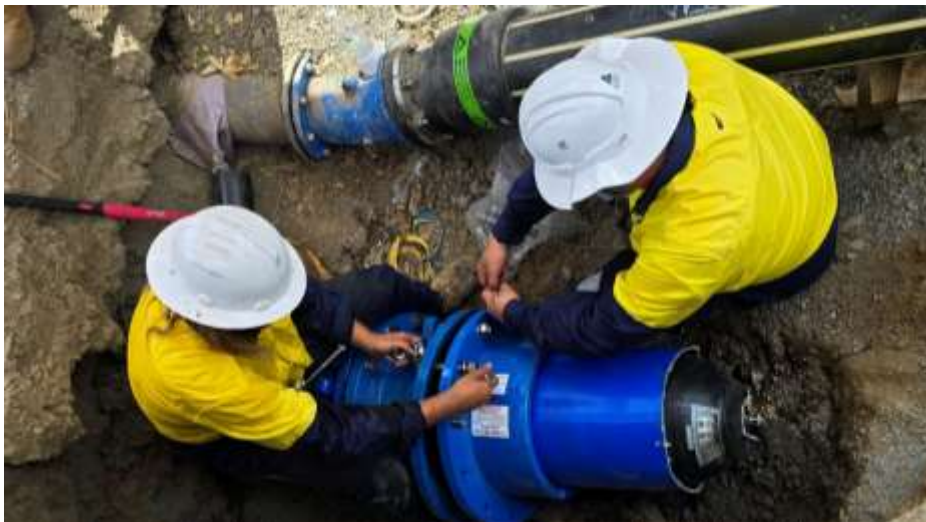
*Figure 5: Installation of the Primus Line end connector at the Hope Island Road entry pit. The blue connector body provides the mechanical and pressure-tight transition between the Primus Liner and the existing flanged network connection.*

End connectors were then installed onto flanged gibaults and torqued at both access pits, integrating the rehabilitated section with the existing recycled water network. The road surface above the entire 130 m pipeline route remained undisturbed throughout. Total Primus Line installation time, including both connector installations, was about 16 working hours.

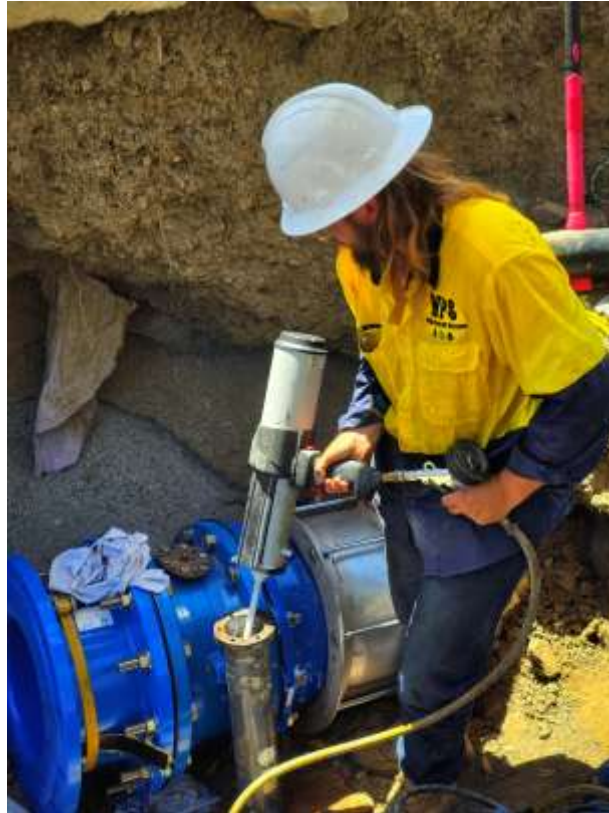
*Figure 6: A Primus Line DN400 PN16 R connector was chosen for the installation. Though flanges it connects on side back to the host pipe and on the opposite side back to the existing pipeline system.*

The Primus Line system DN400 PN18 with connectors PN16 was selected. This Primus Liner provides an operating pressure of 18 bar / 1,800 kpa, when installed in a straight pipe and is de-rated to 8.1 bar / 810 kpa when installed through a 90-degree bend – so more than 1.5 times the maximum operating pressure of the main of 7.5 bar / 750 kpa / 75mh; also delivering a safety factor appropriate for a recycled water transmission main subject to pressure transients. The pressure rating is achieved by the aramid fabric layer operating entirely independently of the host pipe; no contribution from the DICL or PVC host is assumed or required.

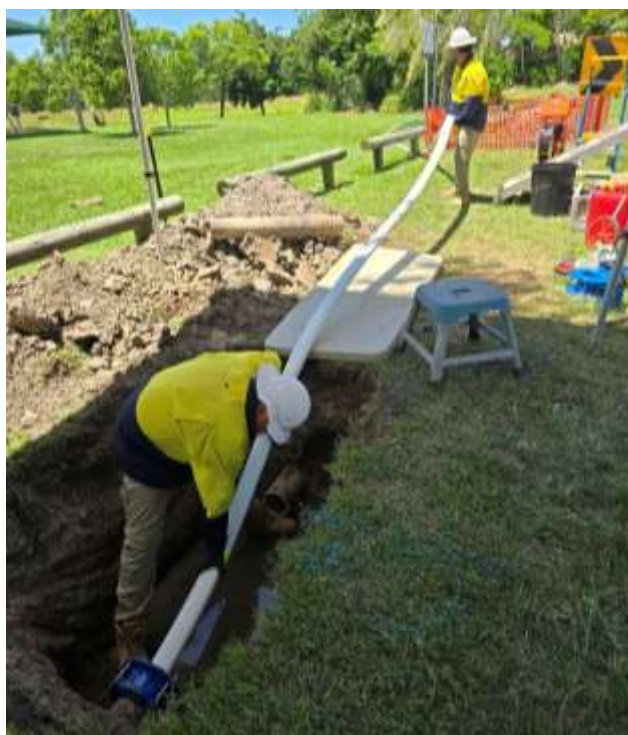
*Figure 7: The construction footprint for the installation of the Primus Liner DN150 is extremely small.*

Two projects involved potable water mains that had failed beneath protected trees — one DN150 PVC (35 m) and one DN150 asbestos cement (50 m). In both cases, open-cut excavation would have required significant disturbance to the tree root zone, raising environmental, community, and potentially legal concerns. A Primus Liner DN150 PN25 was selected for both, with material sourced from Sydney stock and mobilised to site within days. Installation from two small access pits preserved the root zones entirely; the sections were pressure tested and returned to potable water service without incident.
