# RESOLVING CRITICAL FILTRATION IMBALANCES AND OBSOLESCENCE THROUGH ULTRASONIC FLOW MEASUREMENT AT DUNGOG WTP

**Kim O'Rourke**, *Project Engineer*, Veolia (Hunter Water Treatment Alliance)

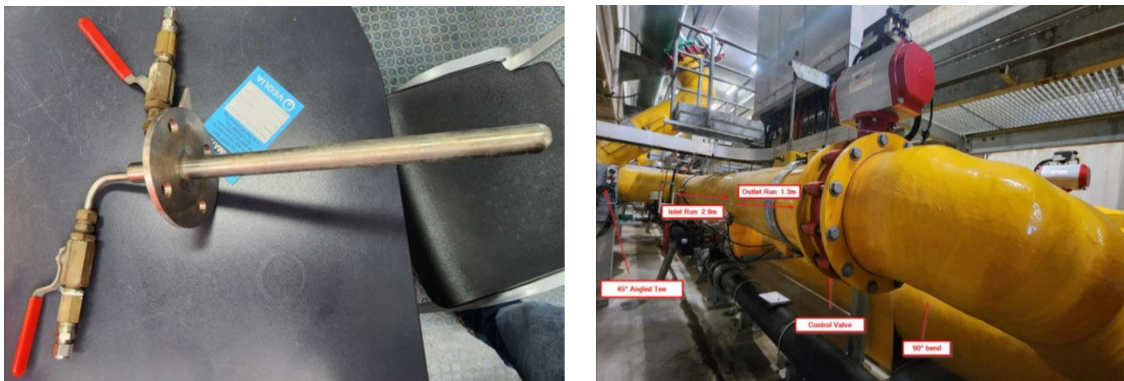
- The existing flow meters had insufficient Inlet/Outlet Runs in the process.
- The existing flow meters had inadequate selection of differential pressure flow element that should not be used for reporting or flows of importance under current legislation.
- The existing flow meters had inadequate choice of flow measurement principle given the process conditions and the purpose of measurement.
- The flow meters were also causing a low flow blind spot with and absence of flow reading below 1ML/d.

Figure 1 Existing Pitot Tube removed from pipework and the challenges of the GRP pipework

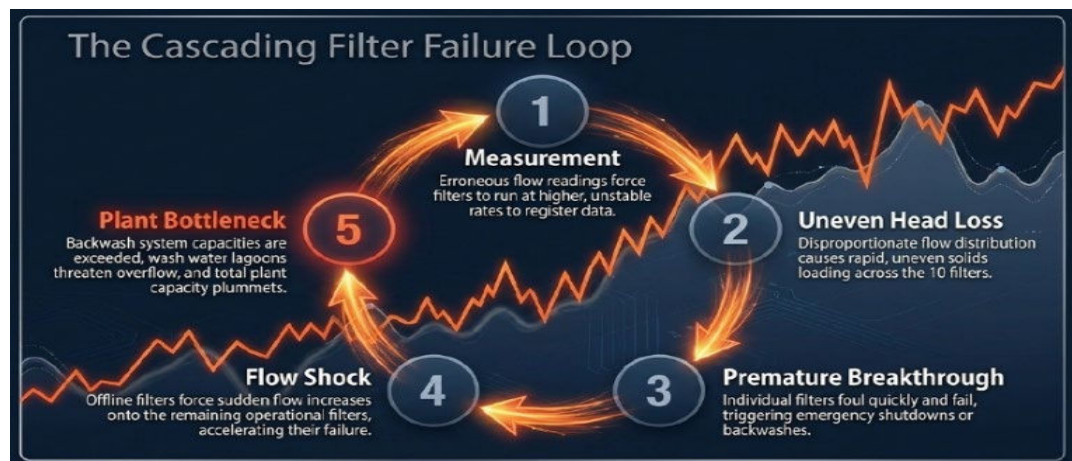
- **Production / Service interruption** – cascading filter failures during periods of low flows. The periods of low flow is predominantly initiated as a response to either low supply demand or poor raw water quality events.

Figure 2: Cascading filter failure further explained.

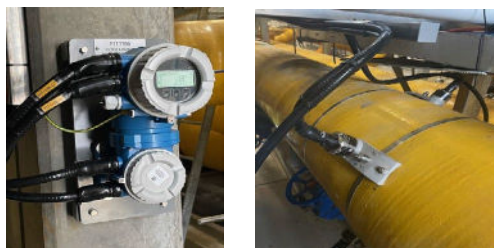
Figure 7: The Clamp-On Flow Meter in position at filter 5 outlet on site.

The project successfully delivered the installation of ten flow meters on time and on budget with minimal down time to the process and minimal invasion to the infrastructure.
