# INSPECTING SERVICE RESERVOIRS FOR WATER QUALITY NOW!

*10<sup>th</sup> Annual WIOA  
NSW Water Industry Operations Conference and Exhibition  
Newcastle Jockey Club,  
6 to 7 April, 2016*

**David Barry**, *Director*, Aqualift Project Delivery Pty Ltd

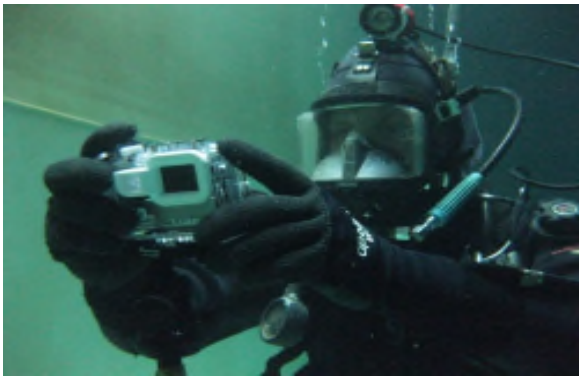
**Figure 9:** *Diver Inspections*

While this segment can be done by diving or Remote Operated Vehicle (ROV) (Figures 9 & 10), not everyone is competent in recognising some of the specialised issues. Pipework designs for example are often overlooked during contamination orientated inspections.
