# CLEAR WATER TANK CAPERS: AN OPERATOR'S VIEWPOINT

**Travis Hutton, Process Operator Trainee,**

Tamworth Regional Council

*10<sup>th</sup> Annual WIOA  
NSW Water Industry Operations Conference and Exhibition  
Newcastle Jockey Club,  
6 to 7 April, 2016*

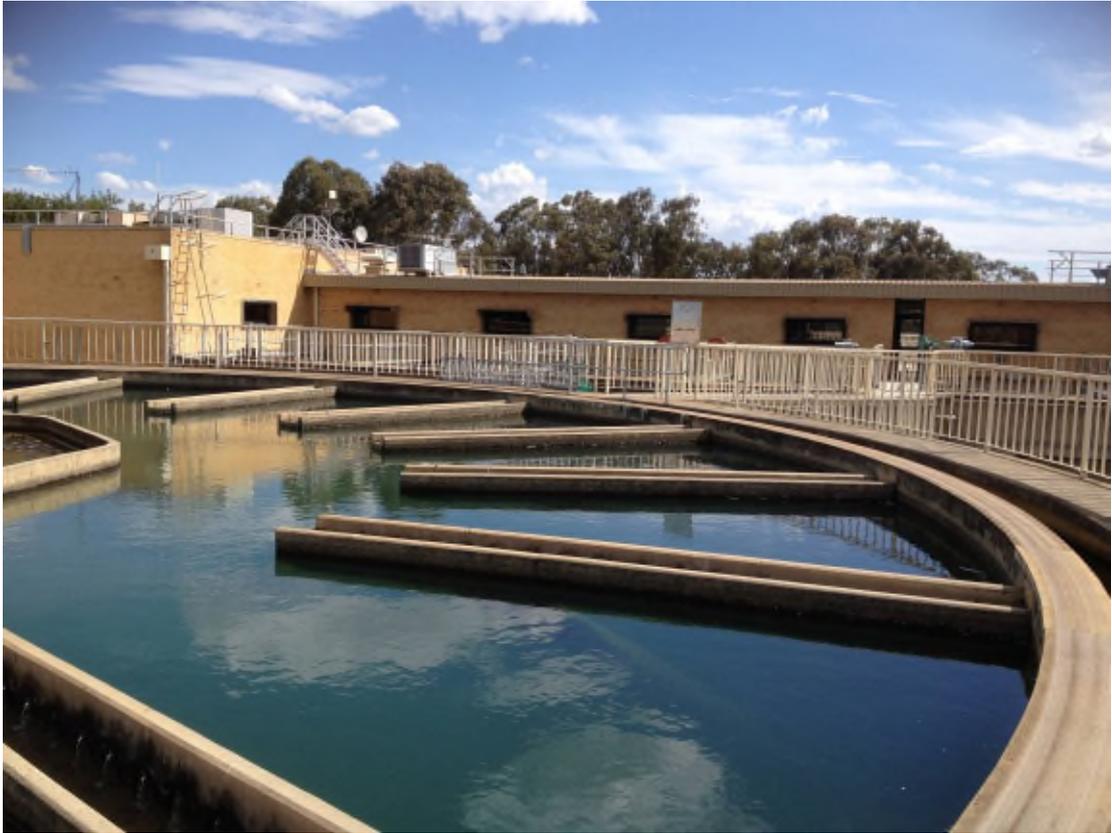
**Figure 6:**     *Clarifier at Calala Water Treatment Plant (Tamworth)*

In my opinion this major problem was ultimately caused by a design flaw. Placing a clarifier on top of a Clear Water Tank with the benefit of hindsight is clearly a bad idea. Another problem was that the original sludge pipe had insufficient support to carry the weight of the pipe.
