LANDERS SHUTE WTP RAW WATER MAIN DRAIN DOWN, REPAIR & REFILL

Alysha Di Martino, *Operations Process Engineer*, Seqwater
(Co-authors if any) Chris Brown, *Operator Supply*, Seqwater
ABSTRACT

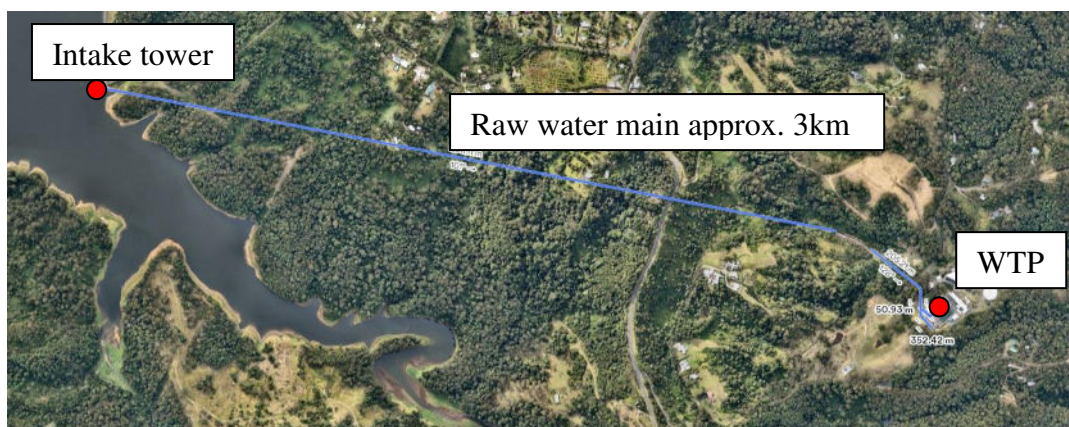
Figure 3 Aerial photo showing the length of the raw water main to the WTP

Unfortunately, there are no section isolation valves upstream of the raw water lime dosing pit. Therefore, to de-pressurise the main, the entire raw water main from the intake tower at the dam to the WTP would have to be drained, this is approximately 2 ML of water. Refer to Figure 3 & Figure 4 below which show the raw water main in blue. The raw water main is a OD1086 mild steel cement lined pipe. The raw water main had never been drained before and it presented significant risks that needed to be managed.
