LANDERS SHUTE WTP RAW WATER MAIN DRAIN DOWN, REPAIR & REFILL

Alysha Di Martino, *Operations Process Engineer*, Seqwater
(Co-authors if any) **Chris Brown**, *Operator Supply*, Seqwater
ABSTRACT

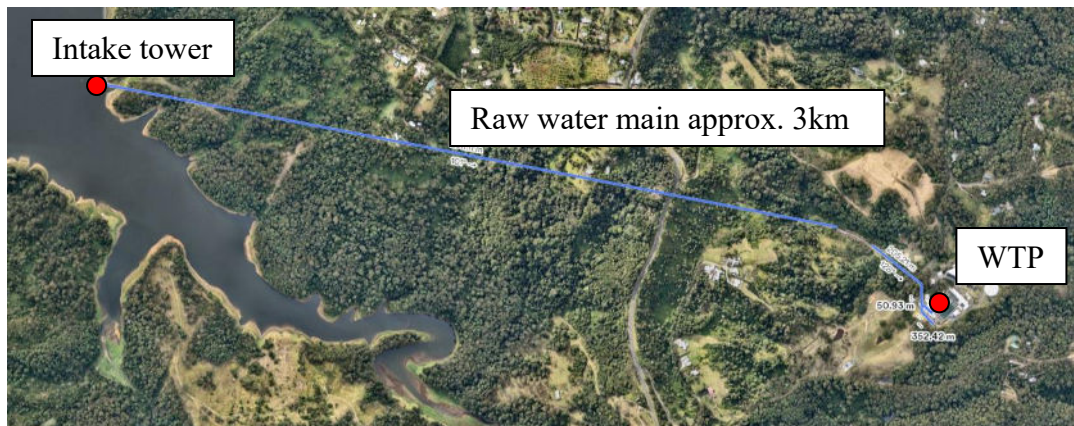
Figure 3 Aerial photo showing the length of the raw water main to the WTP

Unfortunately, there are no section isolation valves upstream of the raw water lime dosing pit. Therefore, to de-pressurise the main, the entire raw water main from the intake tower at the dam to the WTP would have to be drained, this is approximately 2 ML of water. Refer to Figure 3 & Figure 4 below which show the raw water main in blue. The raw water main is a OD1086 mild steel cement lined pipe. The raw water main had never been drained before and it presented significant risks that needed to be managed.
