OPTIMISATION OF THE DORA CREEK IDEA WASTEWATER TREATMENT PLANT

John Stevens, *Wastewater Treatment Plant Operator, Hunter Water*

ABSTRACT

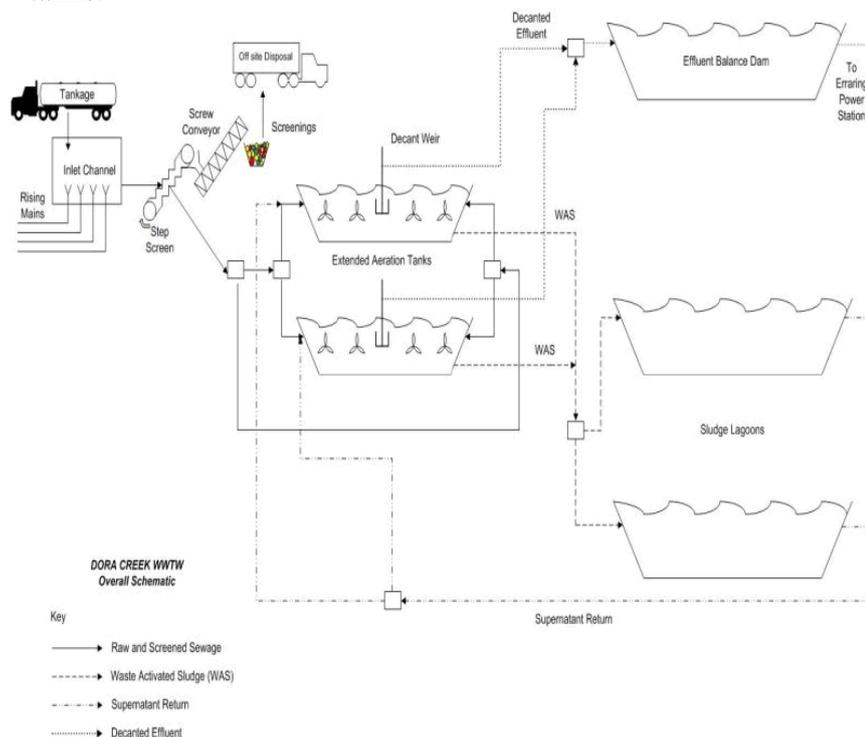
Dora Creek has a design capacity of 16,000 EP with an ADF of 3.8 ML/d and a PWWF of 32 ML/d. Treatment of sewage is by screening followed by aeration using four surface aerators in each of two Intermittent Decant Extended Aeration tanks.

Figure 1: Schematic of the Dora Creek WTP

Waste Mixed Liquor is directed to two Sludge Lagoons which are operator controlled. Recommended Sludge age was 25 days and a MLSS of around 2900.

Treated effluent is decanted to a storage pond. Eraring Power Station pump from this pond and use the treated effluent as Boiler Feed Water (used to produce steam and move turbines for electricity), which requires demineralised water to prevent scaling in the heat transfer pipes (i.e. **less frequency of boiler shutdown**).
