RAIN, RAIN, GO AWAY – THE OPERATIONAL CHALLENGES OF USING RECYCLED WATER IN SOUTH WEST VICTORIA

Kath Coughlan, *Coordinator Water Recycling, Wannon Water*

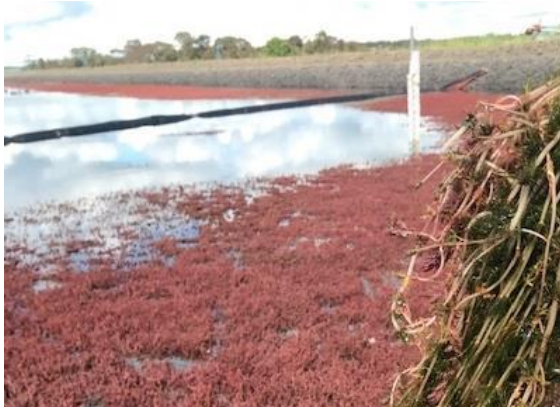
The first step in the ongoing management of the aquatic plants was to have them identified; two native species Red watermilfoil and *Ruppia megacarpa* were identified (**Figure 1**). Through understanding the growth cycle of the plants, targeted management can be designed. Wannon Water is in the early stages of this preventative strategy.

Figure 1: Aquatic plants

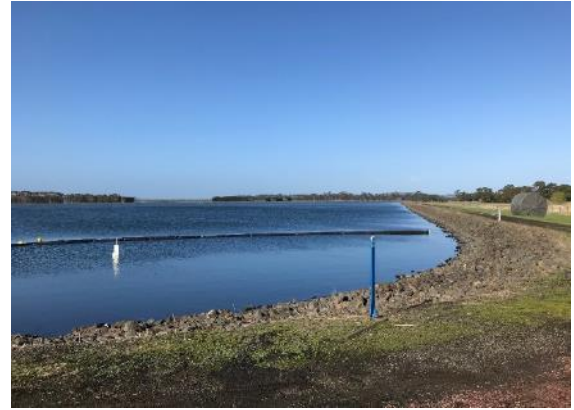
Secondly, a weed curtain was installed in the winter storage to create a clear zone around the pump station suction line (**Figure 2**). The curtain is full depth and permeable, to allow water flow towards the pump and exclude plant material. The curtain is anchored with a one tonne concrete block in the middle to resist the suction of the pump station, with boat winches on either end to adjust the curtain as the water level in the storage changes.

Figure 2: Weed curtain

The need to prevent weed growth inside the weed curtain was also considered. An appropriate aquatic herbicide was selected with expert advice and dosed through liquid injection in late October / November, to coincide with the start of the irrigation season and the peak growth period of the plants. This was highly effective in Spring 2022 with very little growth occurring in the Summer following. While effective in the smaller area inside the curtain, this strategy was considered cost prohibitive in the broader winter storage.

In times of high wind, wind and wave action have blown plant material over the curtain and into the pump zone. Specialised aquatic weed rakes were then used to clear the water inside the curtain. From a safe footing on the banks of the storage, Operations staff throw the rake into the water (with a chain attached), then drag the rake towards the bank. The weed matter is then manually removed. Due to the high potential for contact with recycled water, this strategy is only used as a last resort.

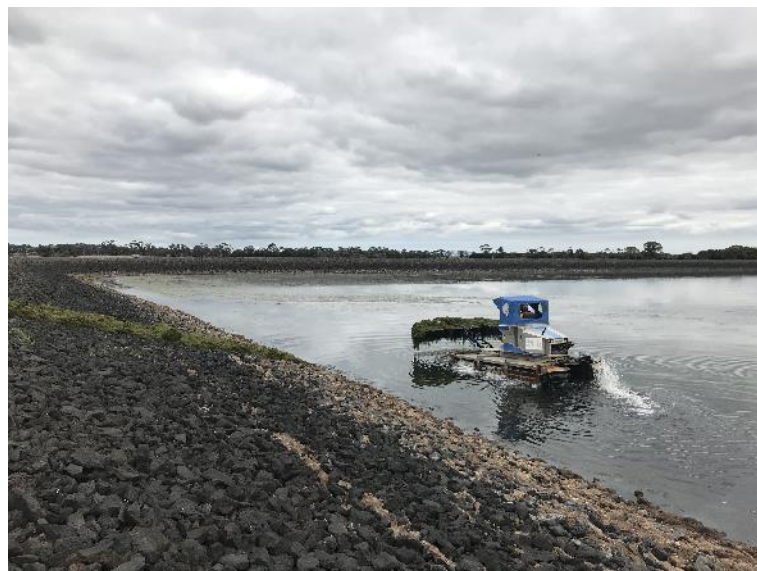
In the broader area of the winter storage, aquatic plants continue to grow, which is monitored on Operator Log Sheets. When surface coverage compromises pump operation, an alert is triggered to initiate manual harvesting of plant material. A contractor with a specialist amphibious craft drives down the banks of the winter storage and onto the water, then traverses the storage collecting floating and submerged plant material. Similar to a terrestrial backhoe, the craft collects a load then drives up the banks of the storage onto a stockpile (**Figure 3**). Over a 290ML storage, this is normally completed within two days and reduces pressure / blockages on the weed curtain.

Figure 3: Amphibious weed harvester

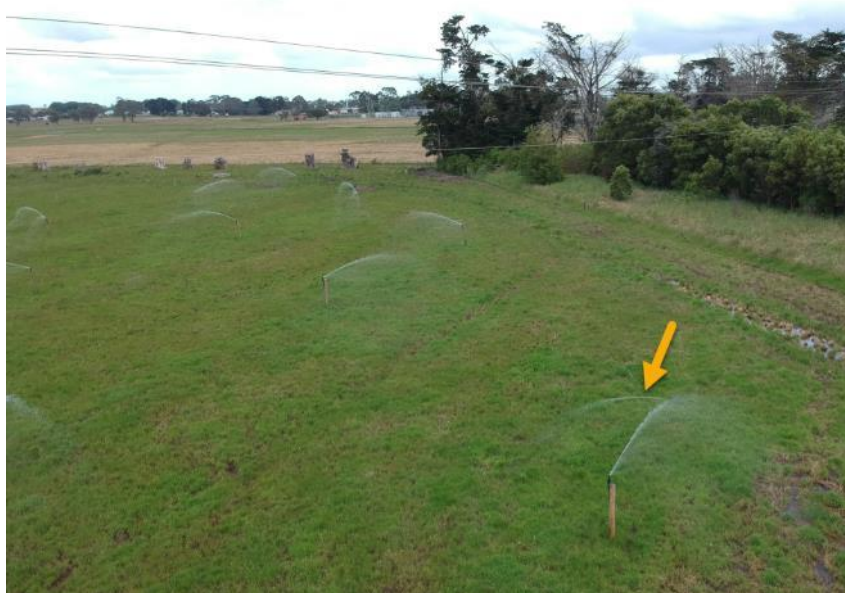
Throughout the upgrade, the system was wet tested on multiple occasions to check for pinching of pipelines and to map damaged sprinkler heads for replacement (individually dismantling 750 sprinklers was considered inefficient). This could be done safely from a closed vehicle for around 50% of the sprinkler area. However, Operators could not get a good line of sight for paddocks in the rear of the property. An innovative solution was to use a drone, allowing a close view for system checks, while staying a safe distance away for Operator health protection. Through this work, multiple sprinklers were identified as having an erratic spray pattern, missing their support post, or missing altogether (**Figure 4**). Using this new monitoring technology, maintenance tasks could be resolved while protecting the health of staff.

Figure 4: Drone monitoring and sprinkler missing a post (arrow)

To address this, the sprinkler system was upgraded in Summer 22/23 by placing all sprinkler heads on a post. This was a considerable upgrade to eliminate grass tangling and livestock trampling issues.
